**ATHOL MANUFACTURING  
DAM**

**MA 00932**

**PHASE I INSPECTION REPORT  
NATIONAL DAM INSPECTION PROGRAM**

**MARCH 1979**

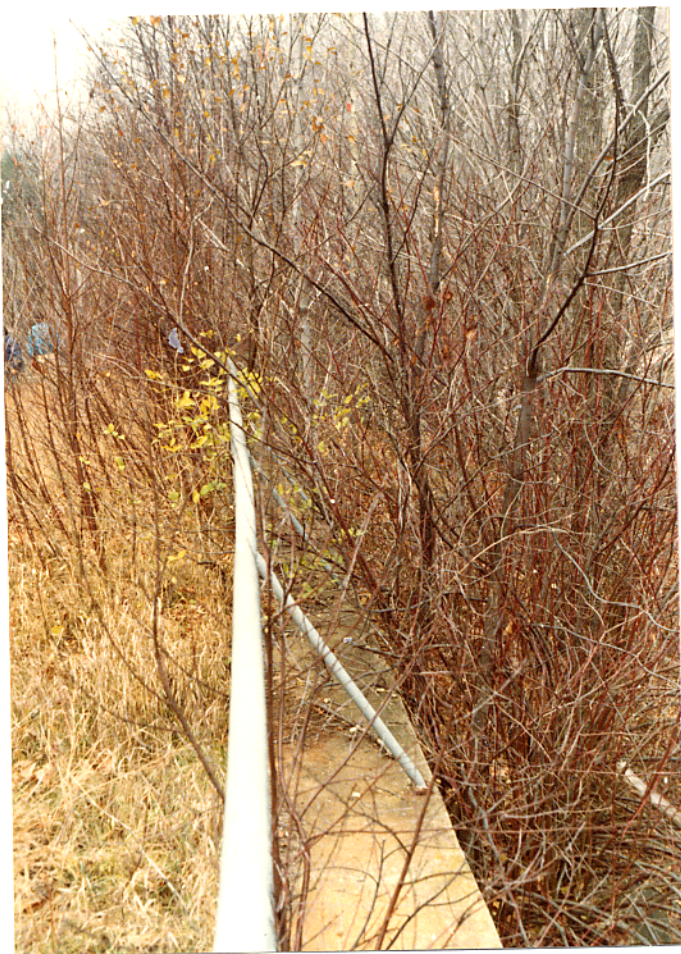
The upstream face of the dam is a reinforced concrete retaining wall, which is in good condition. Cracks that were observed on the face of the wall appeared limited to construction joint locations. The ground surface at the toe of the upstream face of the dam was densely covered with brush and small trees, photo (1). As a result, riprap on the ground surface was not observable.

PHOTO NO. 1 - Crest of dam  
(top of concrete retaining  
wall) viewed from the left  
abutment. Note dense brush  
and tree growth on upstream  
side of the dam.

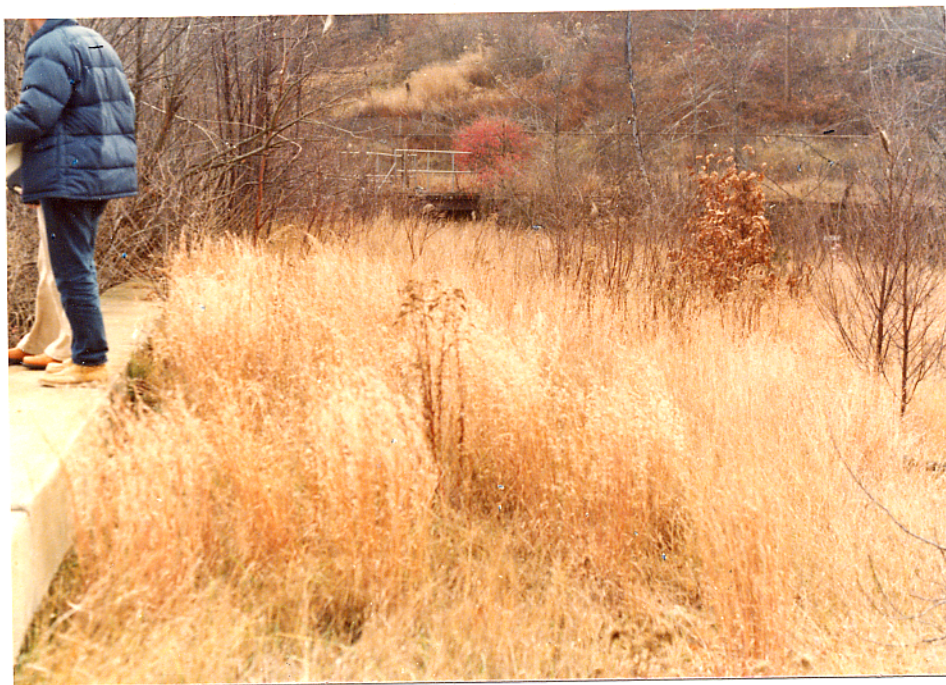
grass and small bushes, photo (2). As a result of the flat topography, the downstream toe was poorly defined. Seeps were not observed on the downstream slope of the dam.

PHOTO NO. 2 - Slope of earth embankment downstream of  
concrete dam viewed from the right abutment.

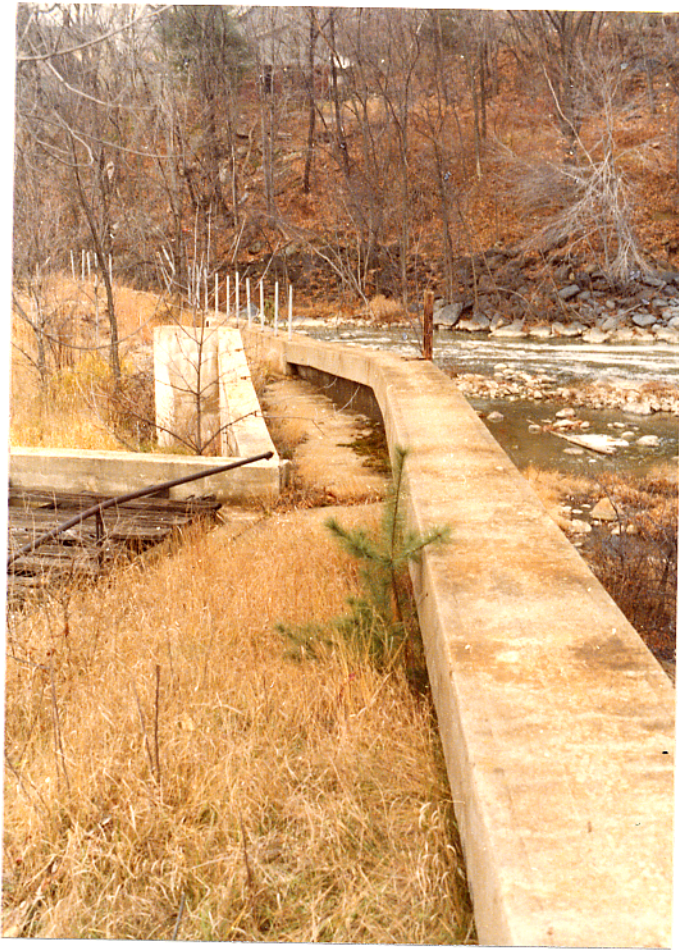
PHOTO NO. 3 - View of concrete retaining wall extending downstream from the dam-overflow spillway junction.

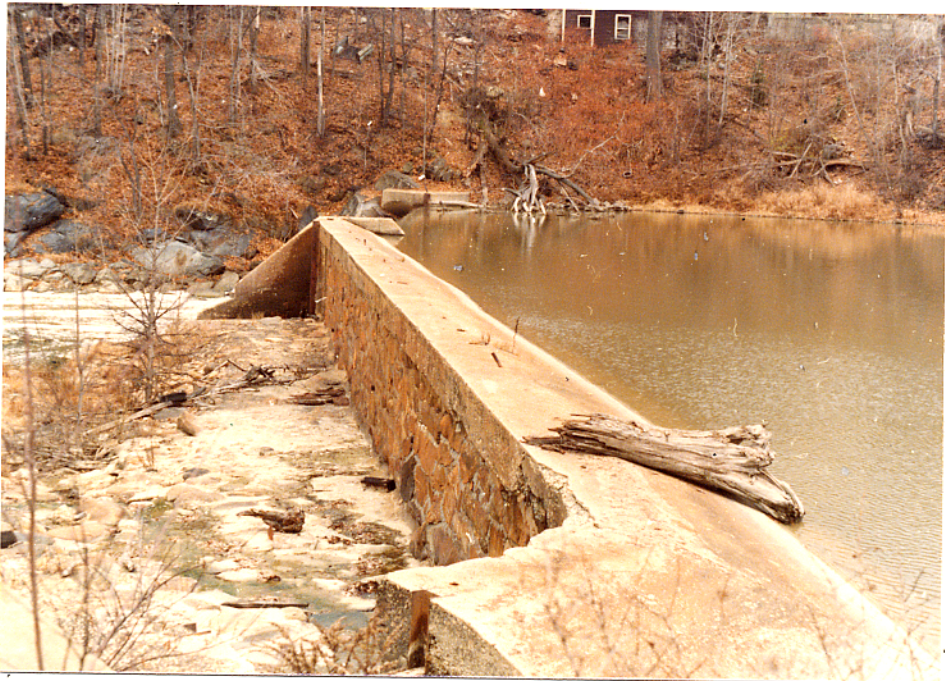
could not be observed. The crest of the overflow spillway had cracks which appeared limited to construction joint locations. Cracks and misalignment of the crest are minor and not considered attributed to movements of the structure. The downstream face of the structure is mortared stone, photo (6). Weep holes present in the downstream face, and several feet below the upstream water surface, did not discharge any water. The downstream toe and channel of the overflow spillway consisted of cobbles grouted in place. The grouted cobble area is generally in good condition with some erosion, small trees and vegetation, photo(4). Seeps were not observed along the toe of the downstream face.

PHOTO NO. 4 - Overflow spillway viewed from junction with the dam. Note spalling of concrete at the bend in the structure and cobbles grouted in place along the toe.

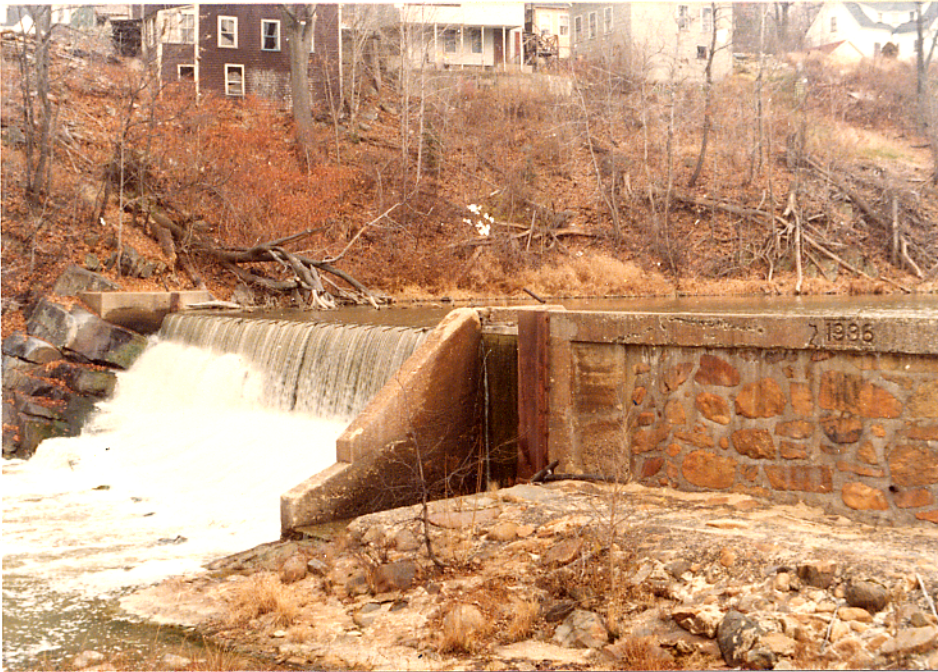
The primary spillway abuts the right side of the river. The structure is bounded on the right by bedrock capped with a concrete block which serves as a training wall and on the left by a concrete training wall, photo(5). The upstream face, crest, downstream face, and apron of the spillway were under water and could not be observed. Flashboards were not present at the time of inspection.

PHOTO NO. 5 - Primary spillway. Note right abutment on bedrock and position of flash board pins.

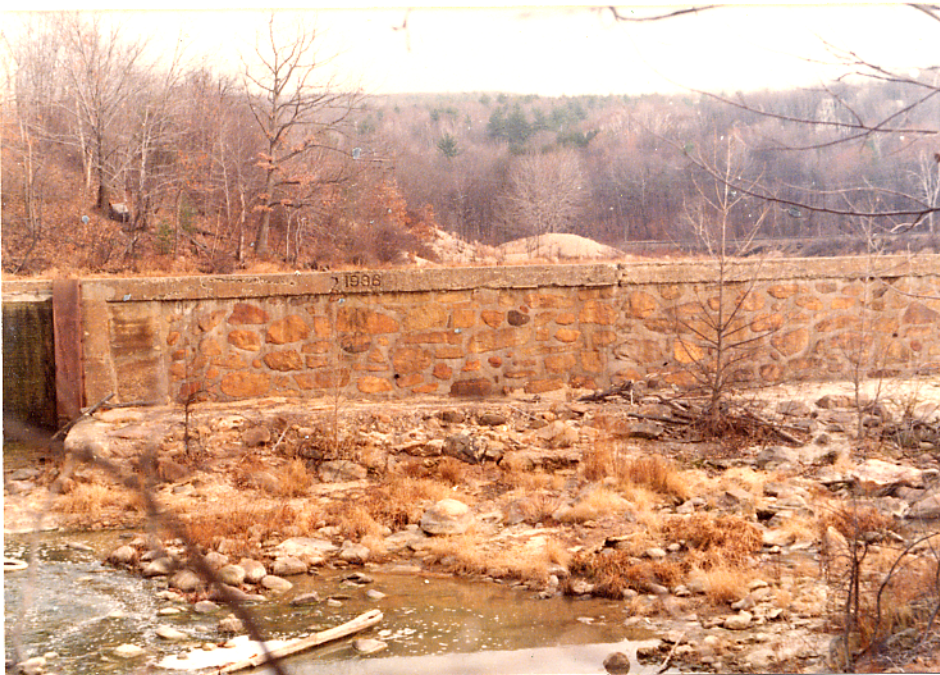
PHOTO NO. 6 - Downstream face of overflow spillway. Note water is not discharging from drain pipes.

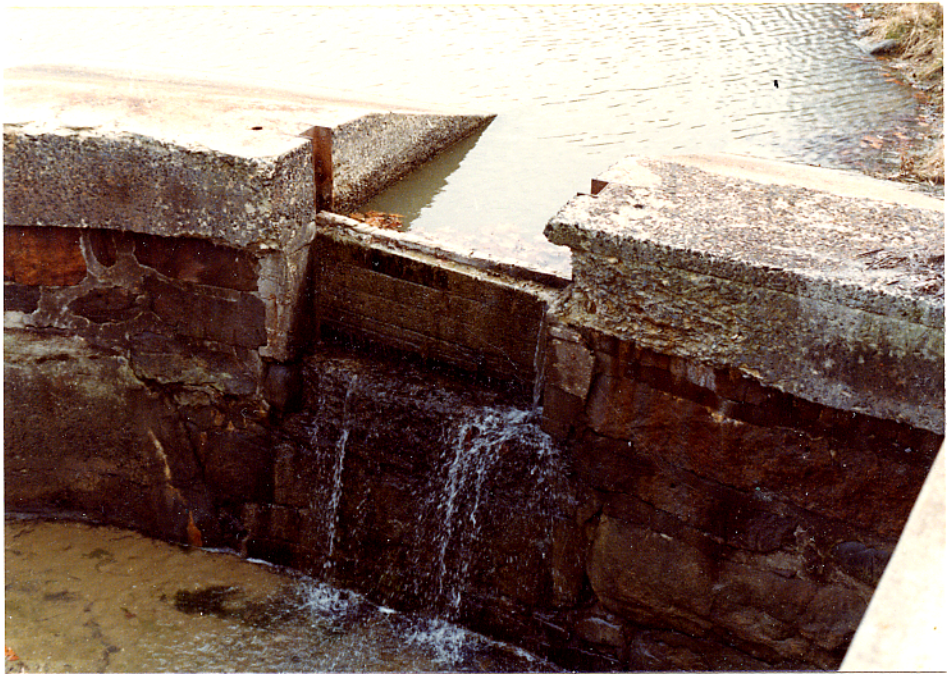
PHOTO NO. 7 - Downstream face of outlet trash gate.

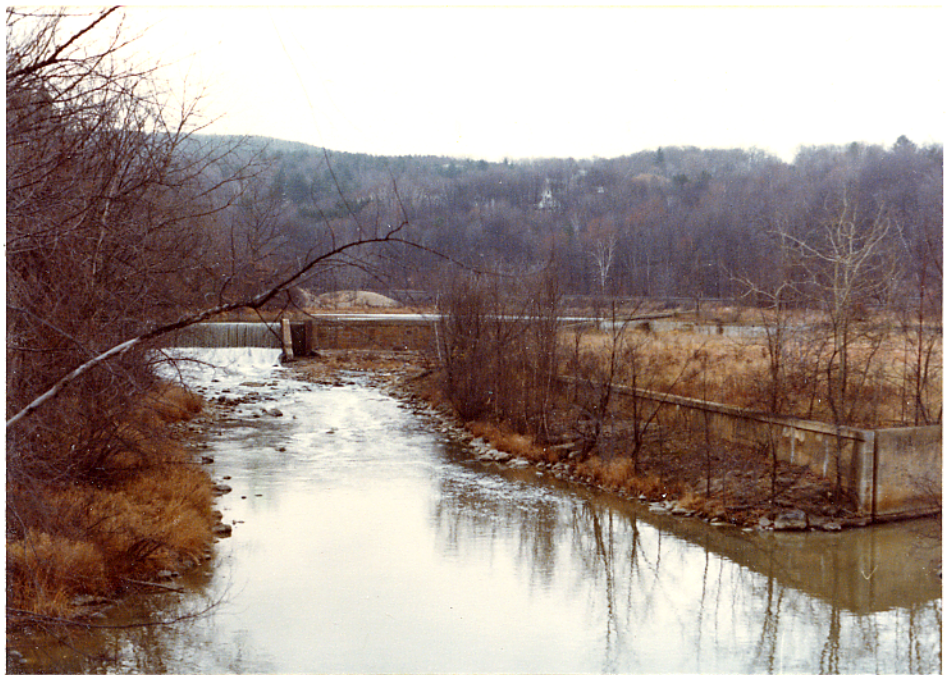
PHOTO NO. 8 - Downstream channel of main spillway viewed from downstream roadway bridge.

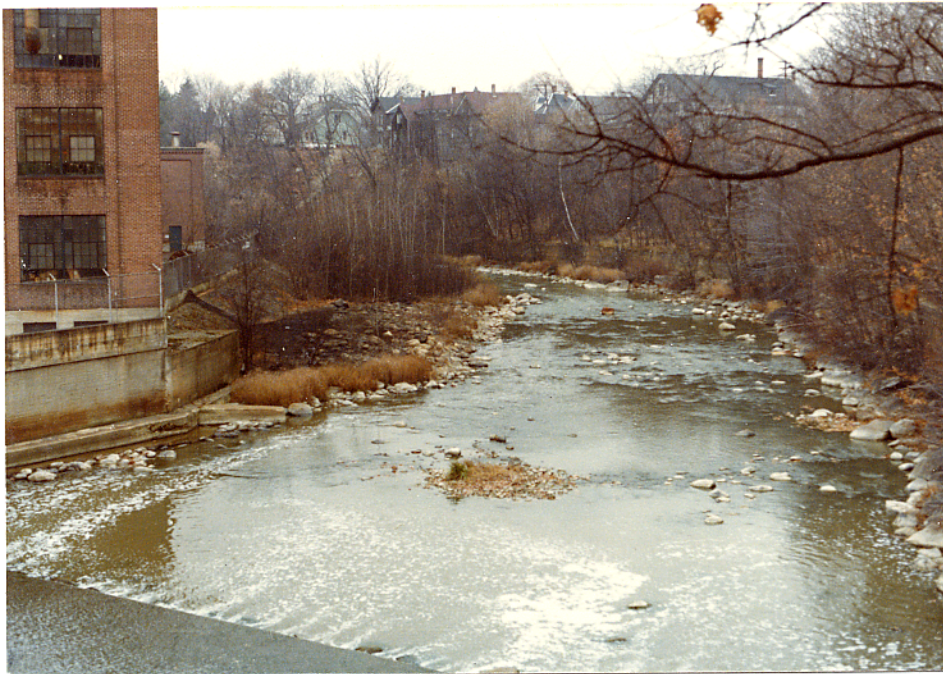
PHOTO NO. 9 - Millers River downstream of roadway bridge viewed from bridge.

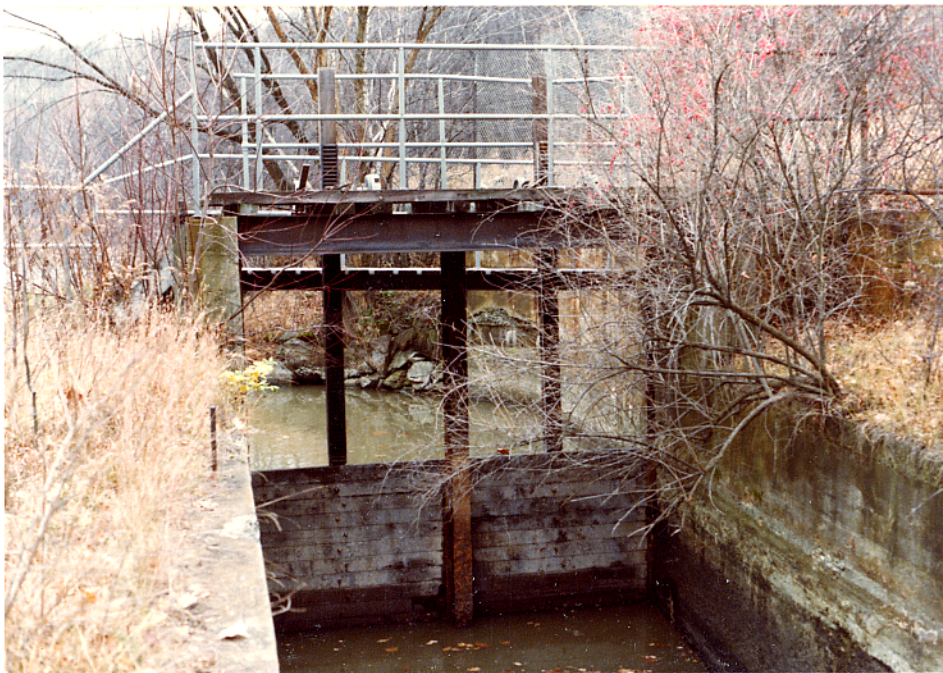
This facility consists of concrete training walls, steel framed, hand operated wooden sluice gate and a service walkway. The training walls were in fair to poor condition with some spalling. The sluice gate and walkway appeared to be in good condition and were last used during the spring of 1978.

PHOTO NO. 10 - Downstream view of outlet sluice gate and service walkway. Facility is used in power generation.
